Lessons from the 2010 Chilean earthquake and its impact on electricity supply

J.C. Araneda, *Senior Member, IEEE*, H. Rudnick, *Fellow, IEEE*, S. Mocarquer, *Member, IEEE*
and P. Miquel

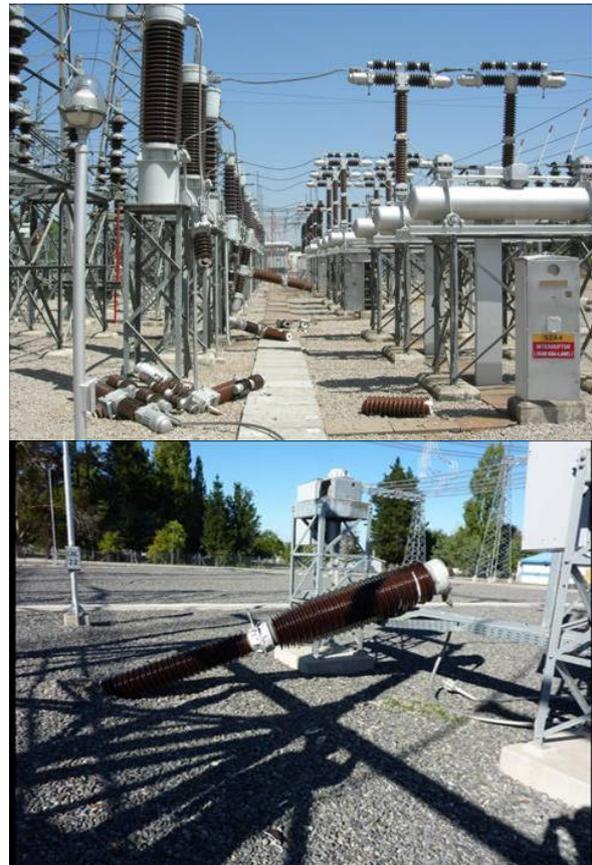
Figure 6.- Transmission equipment damage (Transelec)

Damages at the line level concentrated on 3 towers of the Hualpen-Bocamina 154 kV line. Damages at the substation level were mainly focused on (Figure 6):

- 500 kV bushings
- 500 kV pantograph disconnector switches
- 220 kV circuit breakers (live tank type)
- 154 kV circuit breakers (air compressed type)

– On 30 March, the 154 kV Hualpen-Bocamina line was repaired: two towers without damages at pylons and another was replaced by an emergency structure.

– Damaged bushings from 500 kV reactors at Polpaico substation were sent to its factory in Sweden to investigate its seismic behavior, rectify its design and then repair them.

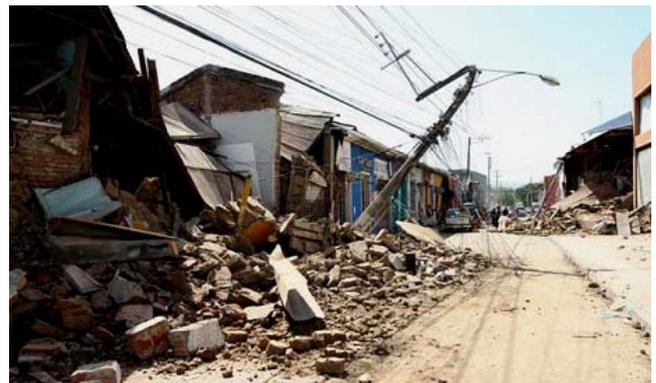
Figure 8.- Effect of earthquake in Talca (Source: CGE)

Some distribution networks were destroyed by the effects of the earthquake, as houses fell over street lines or simply were washed away by the tsunamis (Figures 8 and 9). As an example, 40,000 houses were destroyed out of 1.5 million supplied by CGE.

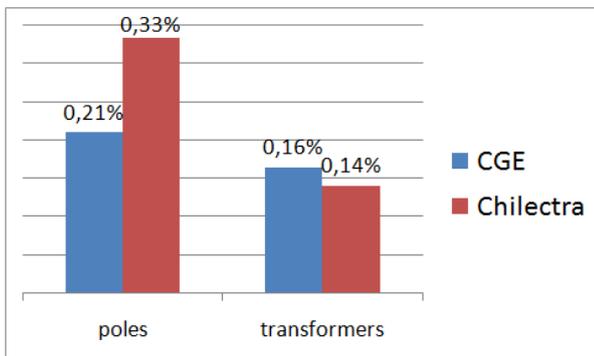
Figure 10.- Distribution equipment damage (Source: Chilectra and CGE)

On the whole, damage to distribution installations was minor, percentage wise. Figure 10 illustrates the percentage of damaged poles and transformers over the total in the two main distribution companies in Santiago (supplied by Chilectra), the capital, and the affected area around Concepcion (supplied by CGE and its subsidiaries). These percentages are for a population of 760,000 poles for CGE and 300,000 for Chilectra, and 50,000 transformers for CGE and 20,000 for Chilectra.
