# Lessons from the 2010 Chilean earthquake and its impact on electricity supply

J.C. Araneda, *Senior Member, IEEE*, H. Rudnick, *Fellow, IEEE*, S. Mocarquer, *Member, IEEE* and P. Miquel

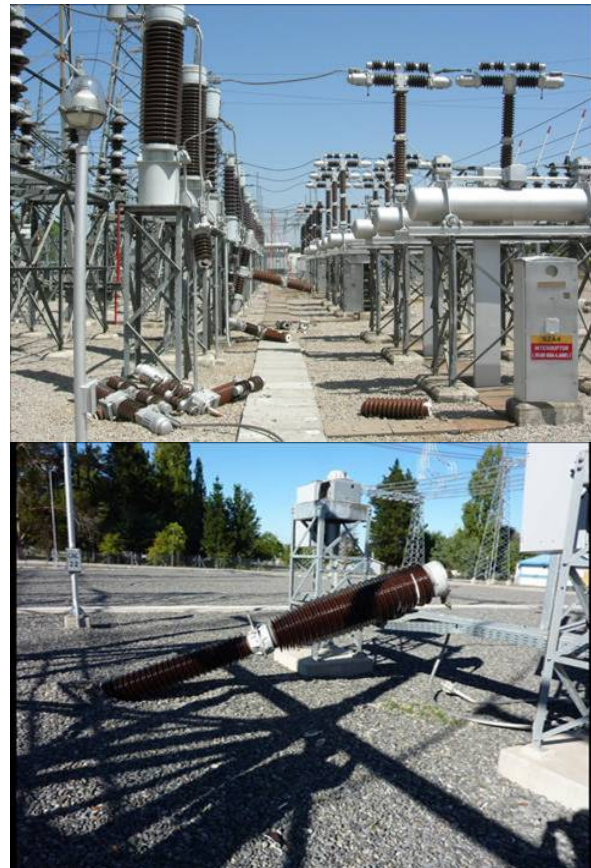
Damages at the line level concentrated on 3 towers of the Hualpen-Bocamina 154 kV line. Damages at the substation level were mainly focused on (Figure 6):

- 500 kV bushings
- 500 kV pantograph disconnector switches
- 220 kV circuit breakers (live tank type)
- 154 kV circuit breakers (air compressed type)

Figure 6.- Transmission equipment damage (Transelec)

– On 30 March, the 154 kV Hualpen-Bocamina line was repaired: two towers without damages at pylons and another was replaced by an emergency structure.

– Damaged bushings from 500 kV reactors at Polpaico substation were sent to its factory in Sweden to investigate its seismic behavior, rectify its design and then repair them.

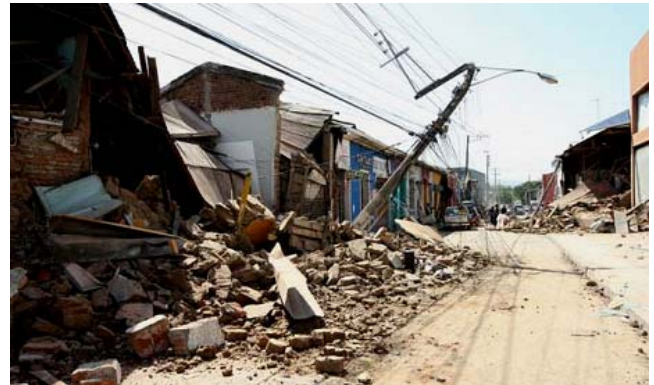
Some distribution networks were destroyed by the effects of the earthquake, as houses fell over street lines or simply were washed away by the tsunamis (Figures 8 and 9). As an example, 40,000 houses were destroyed out of 1.5 million supplied by CGE.

Figure 8.- Effect of earthquake in Talca (Source: CGE)

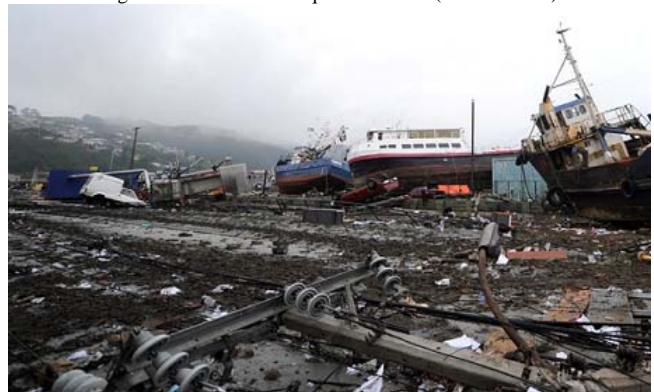
Figure 9.- Effect of tsunami in Talcahuano (Source: CGE)

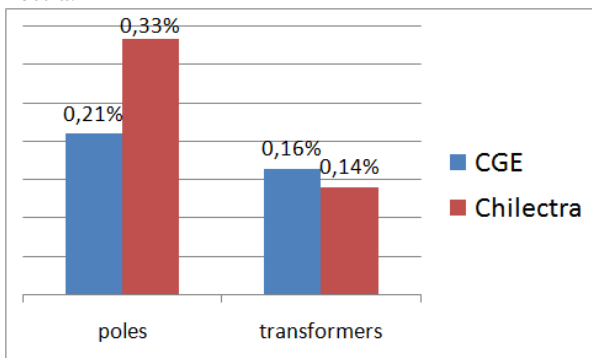
On the whole, damage to distribution installations was minor, percentage wise. Figure 10 illustrates the percentage of damaged poles and transformers over the total in the two main distribution companies in Santiago (supplied by Chilectra), the capital, and the affected area around Concepcion (supplied by CGE and its subsidiaries). These percentages are for a population of 760,000 poles for CGE and 300,000 for Chilectra, and 50,000 transformers for CGE and 20,000 for Chilectra.

Figure 10.- Distribution equipment damage (Source: Chilectra and CGE)
