Lessons from the 2010 Chilean earthquake and its impact on electricity supply

Juan Carlos Araneda, *IEEE Senior* (jcaraneda@transelec.cl)

Hugh Rudnick, *IEEE Fellow* (hrudnick@ing.puc.cl)

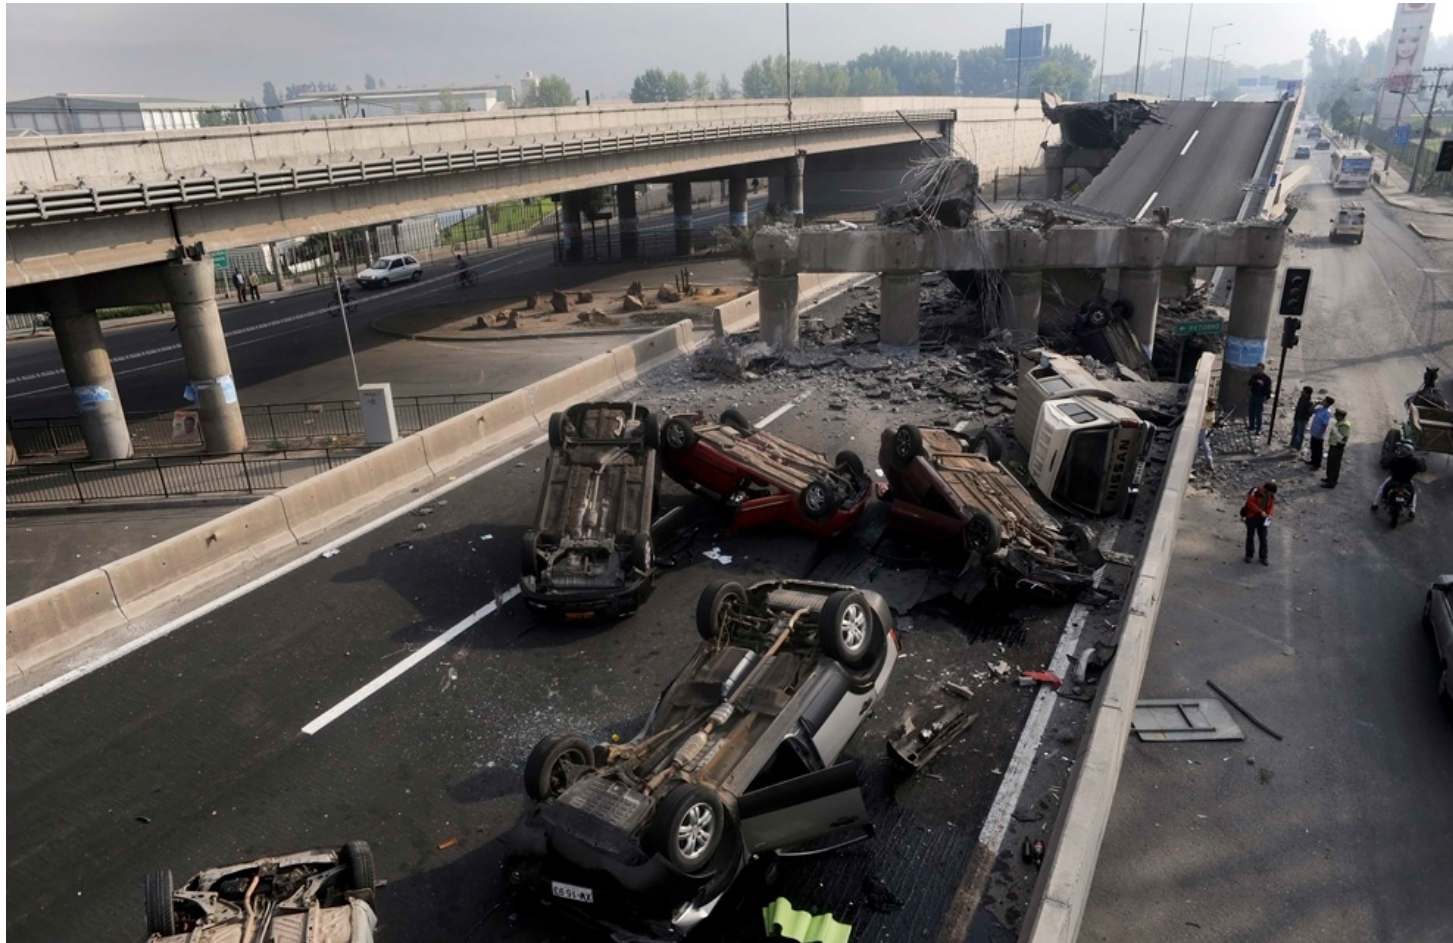
Earthquake effects: infrastructure collapse

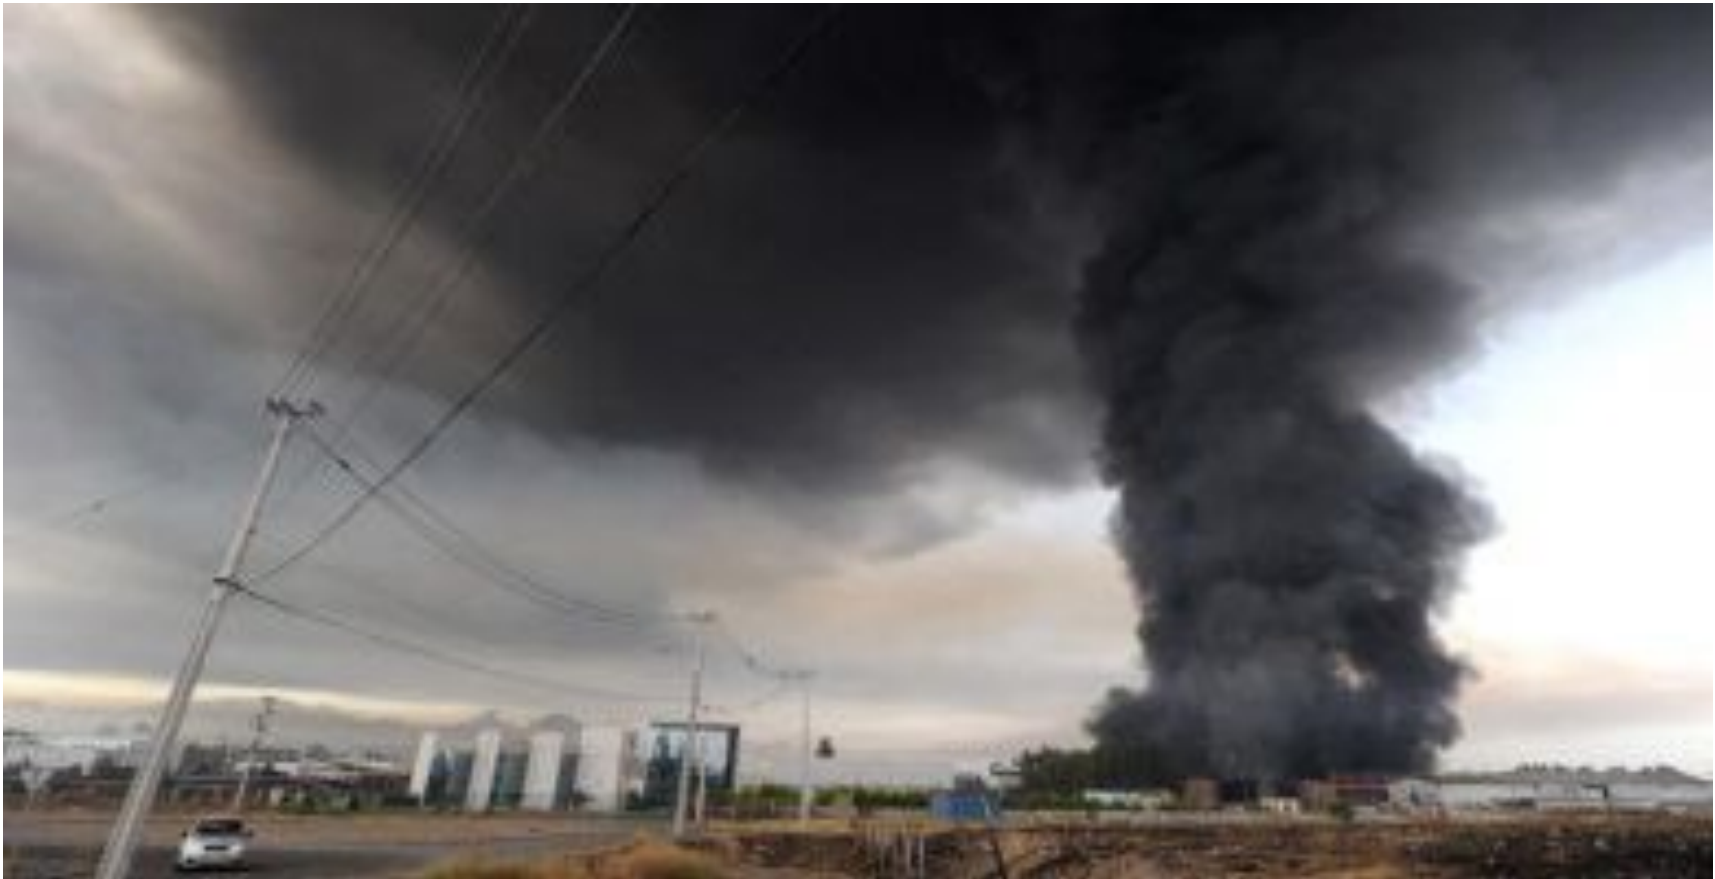
Earthquake effects: large industrial fires

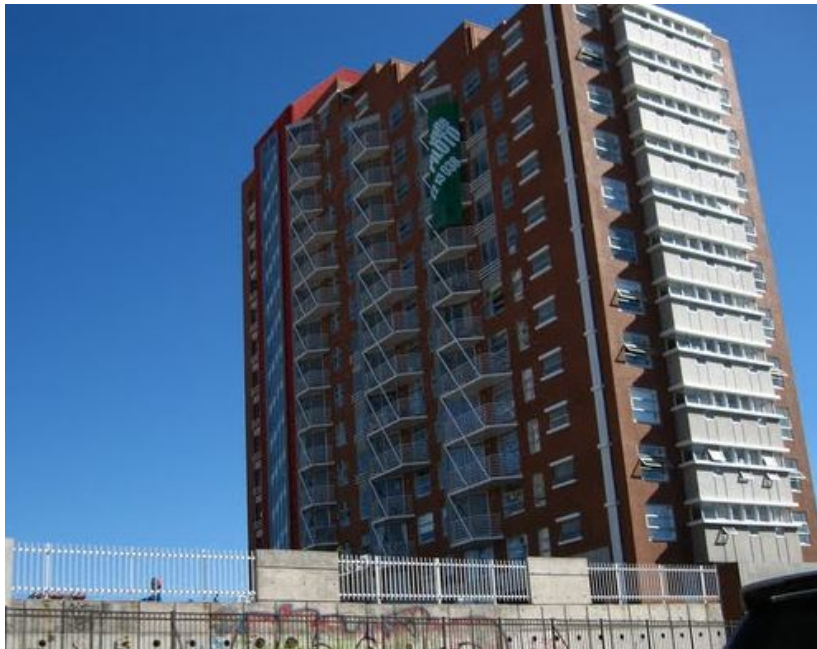
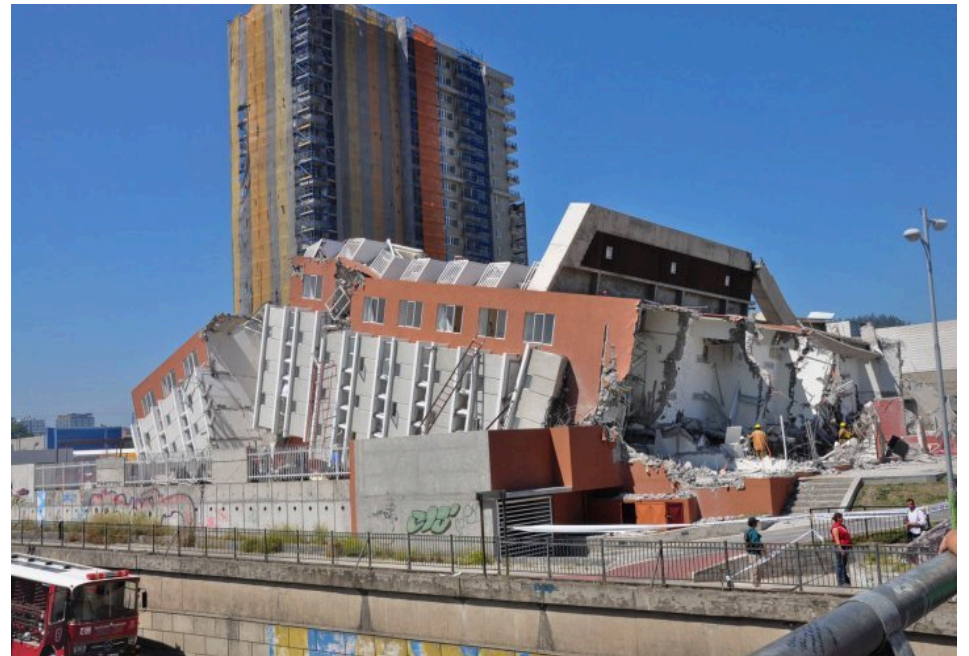
Earthquake effects: structural damage and collapse

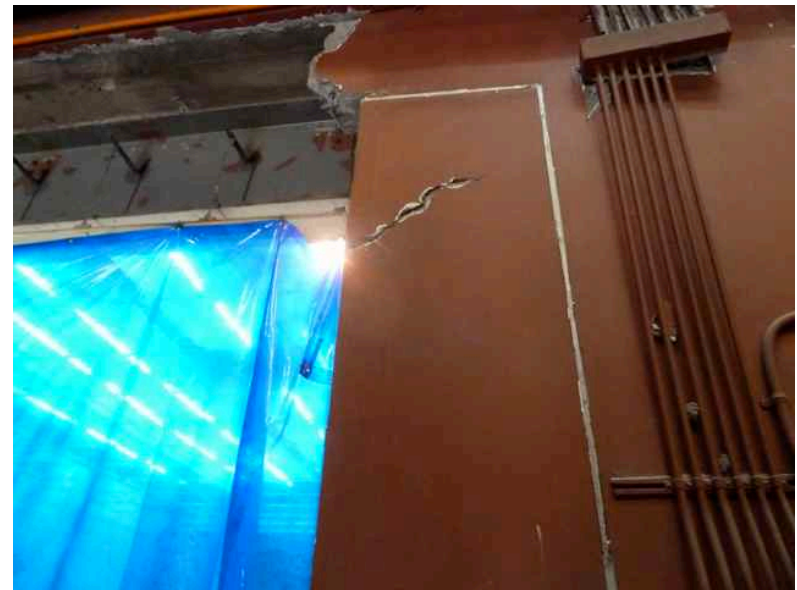
Coal plant chimney fractured

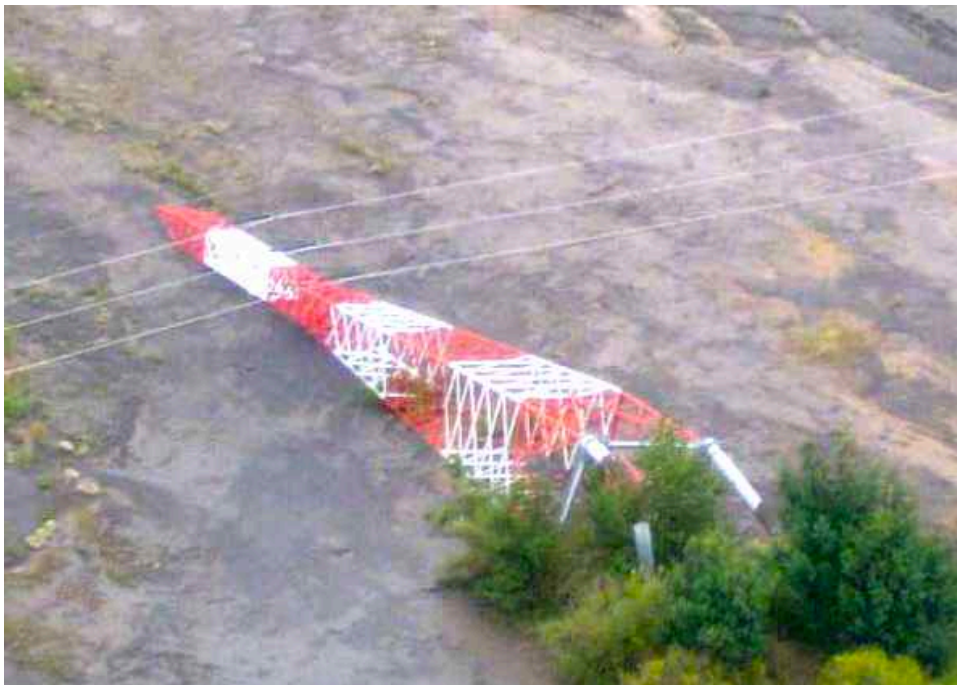
➤ Damage to transmission lines

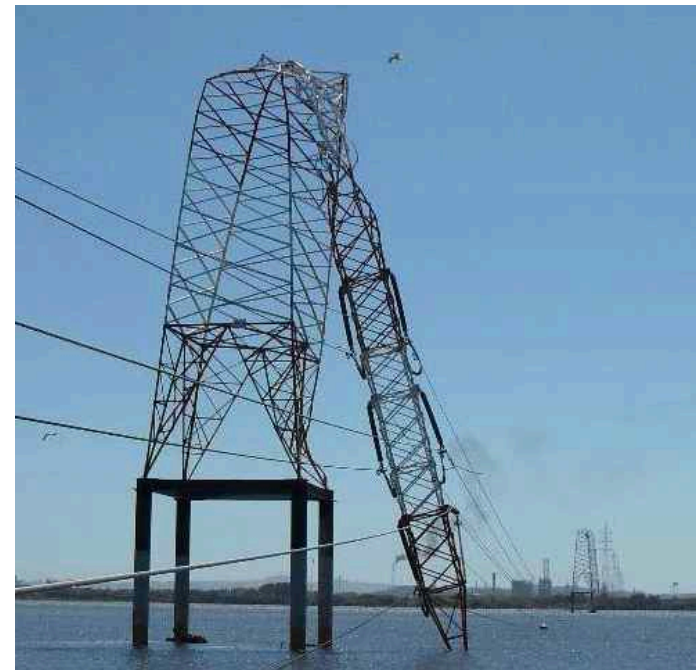
- Damages concentrated in one transmission line
 - 3 towers from 154 kV line
- At substation level the damages were mainly focused at:
 - 500 kV bushings (high failure rate)
 - 500 kV pantograph disconnecter switches
 - 220 kV circuit breakers (live tank type)
 - 154 kV circuit breakers (air compressed type)

Hualpen-Bocamina line (3 towers)

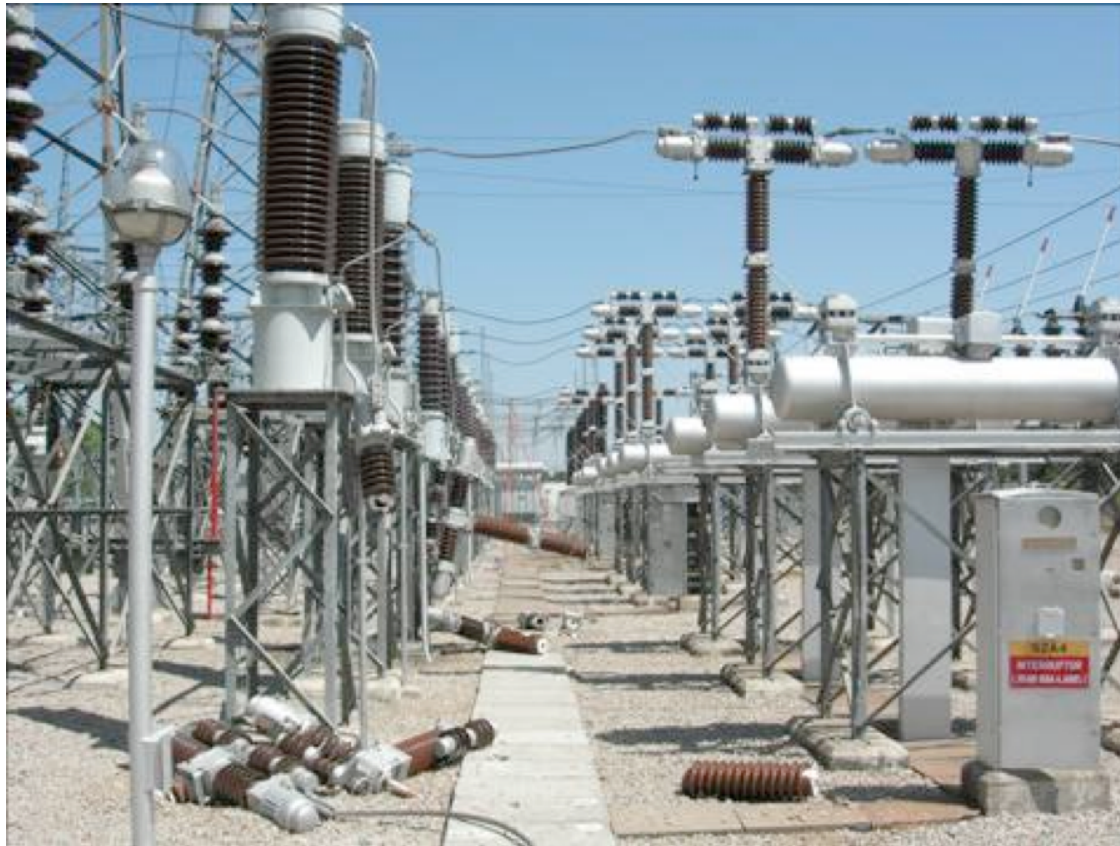
➤ Substation damages

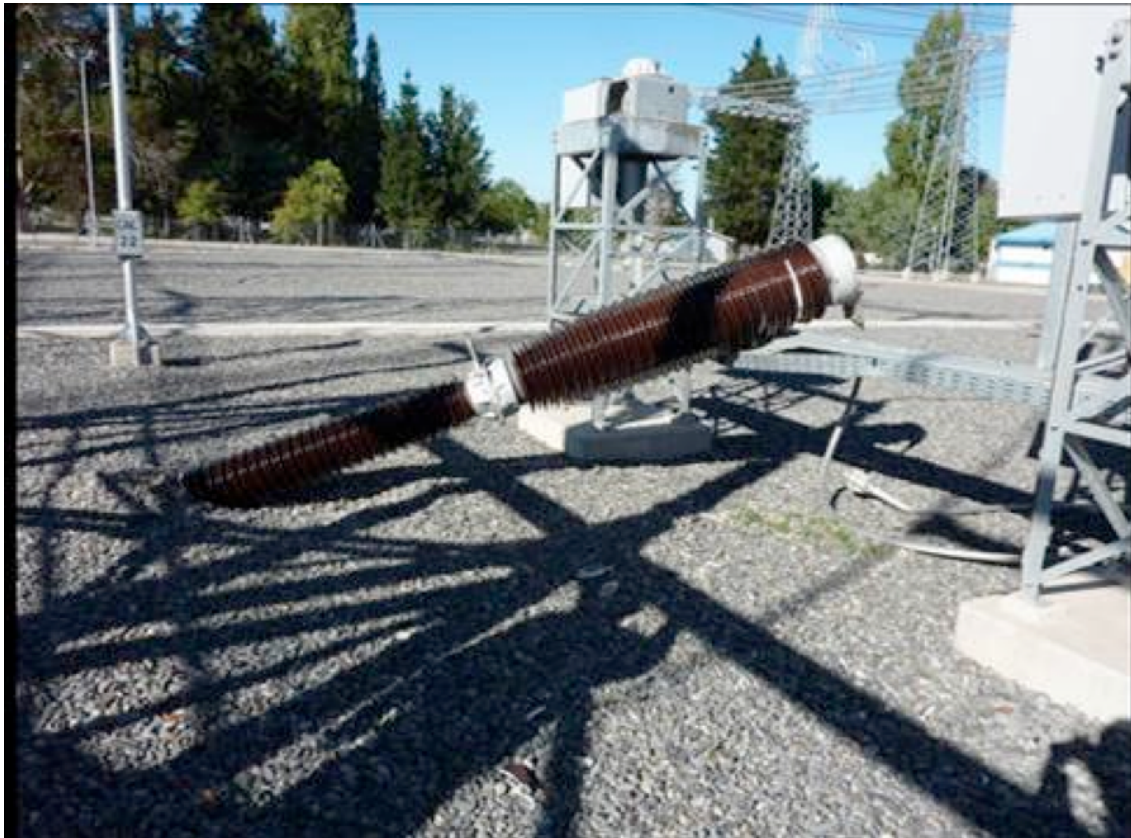
➤ Substation damages

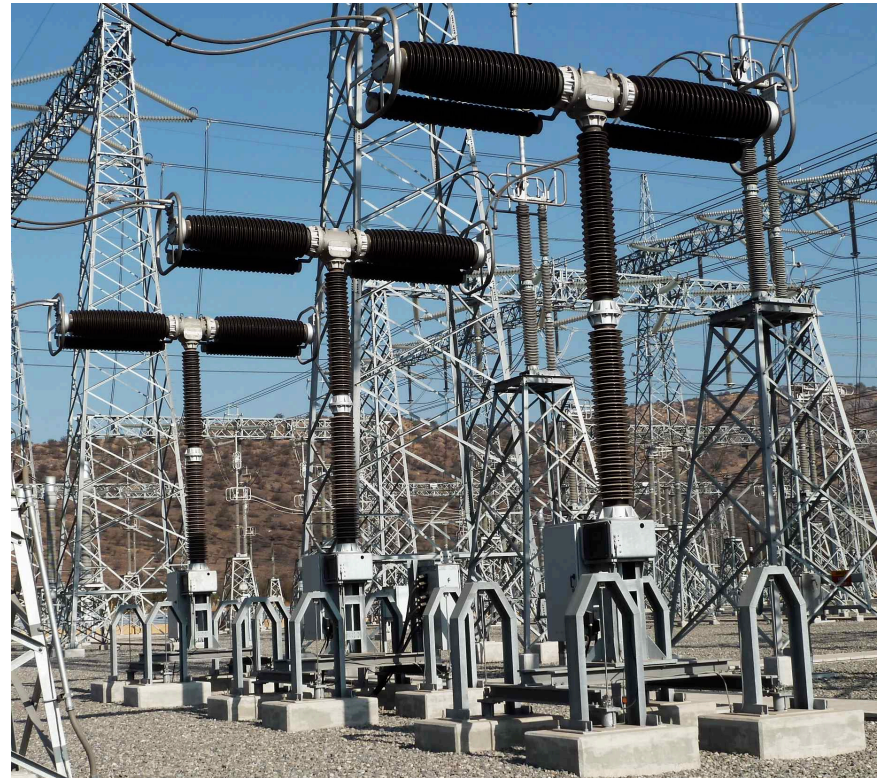
Capacitor bank without damage

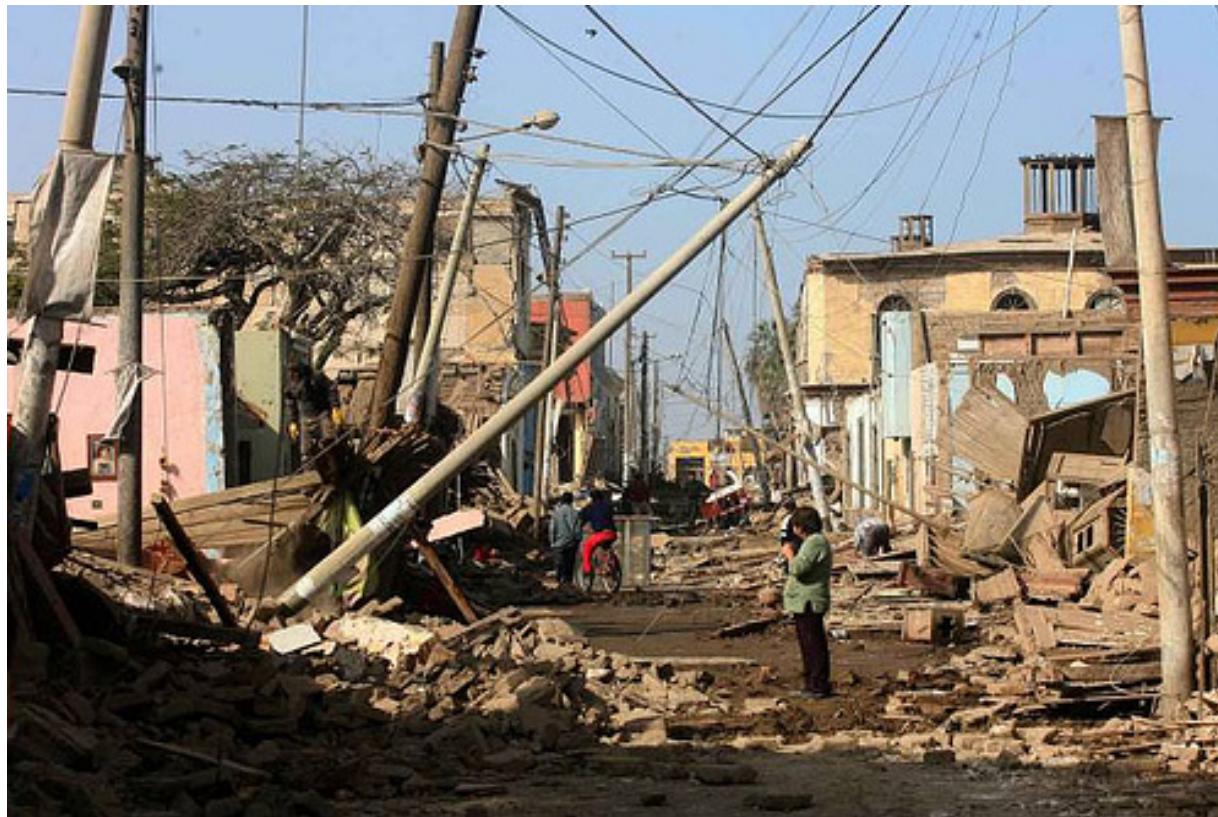
- Extended damage in distribution networks

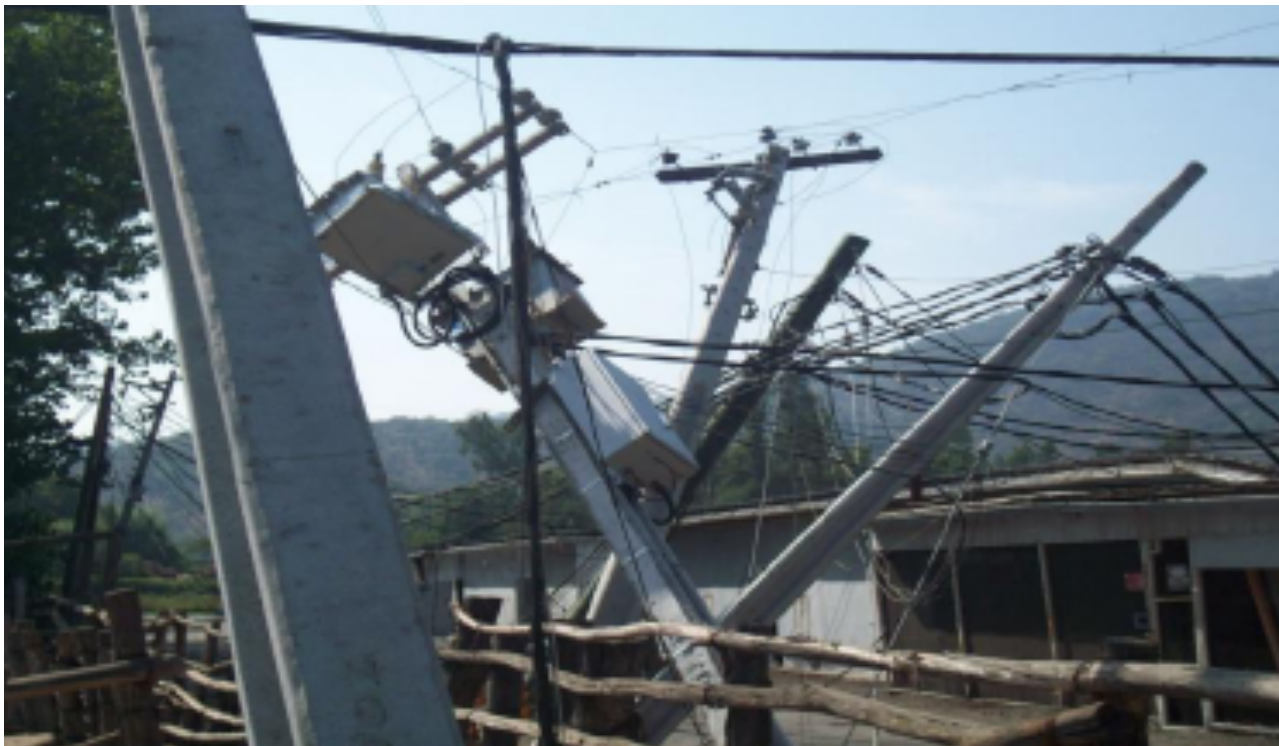
- Extended damage in distribution networks

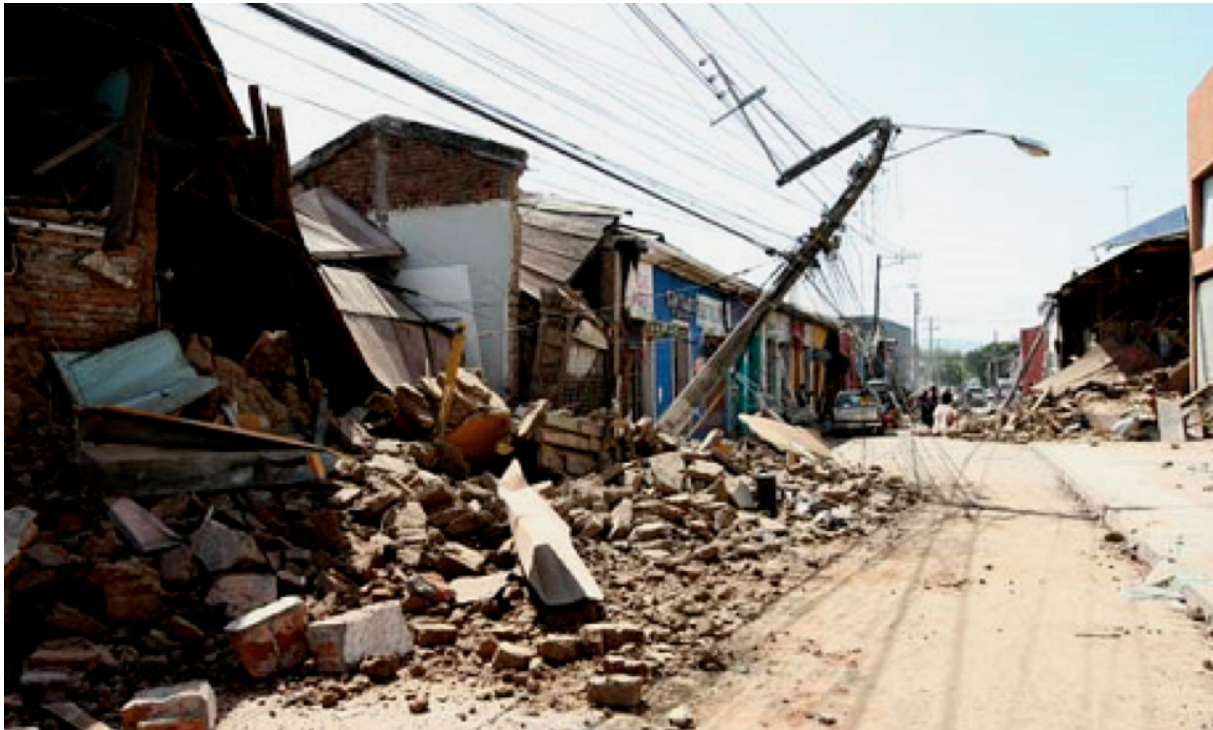
- Extended damage in distribution networks

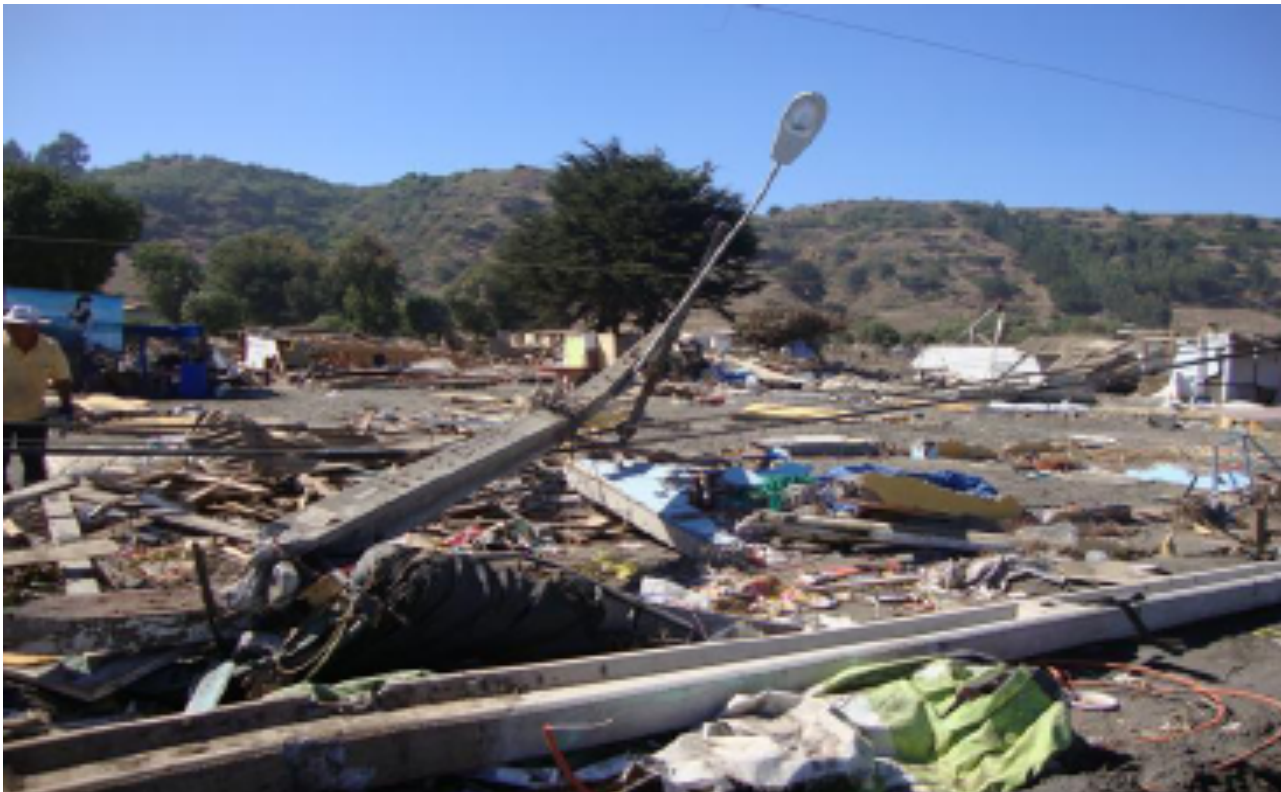
- Extended damage in distribution networks

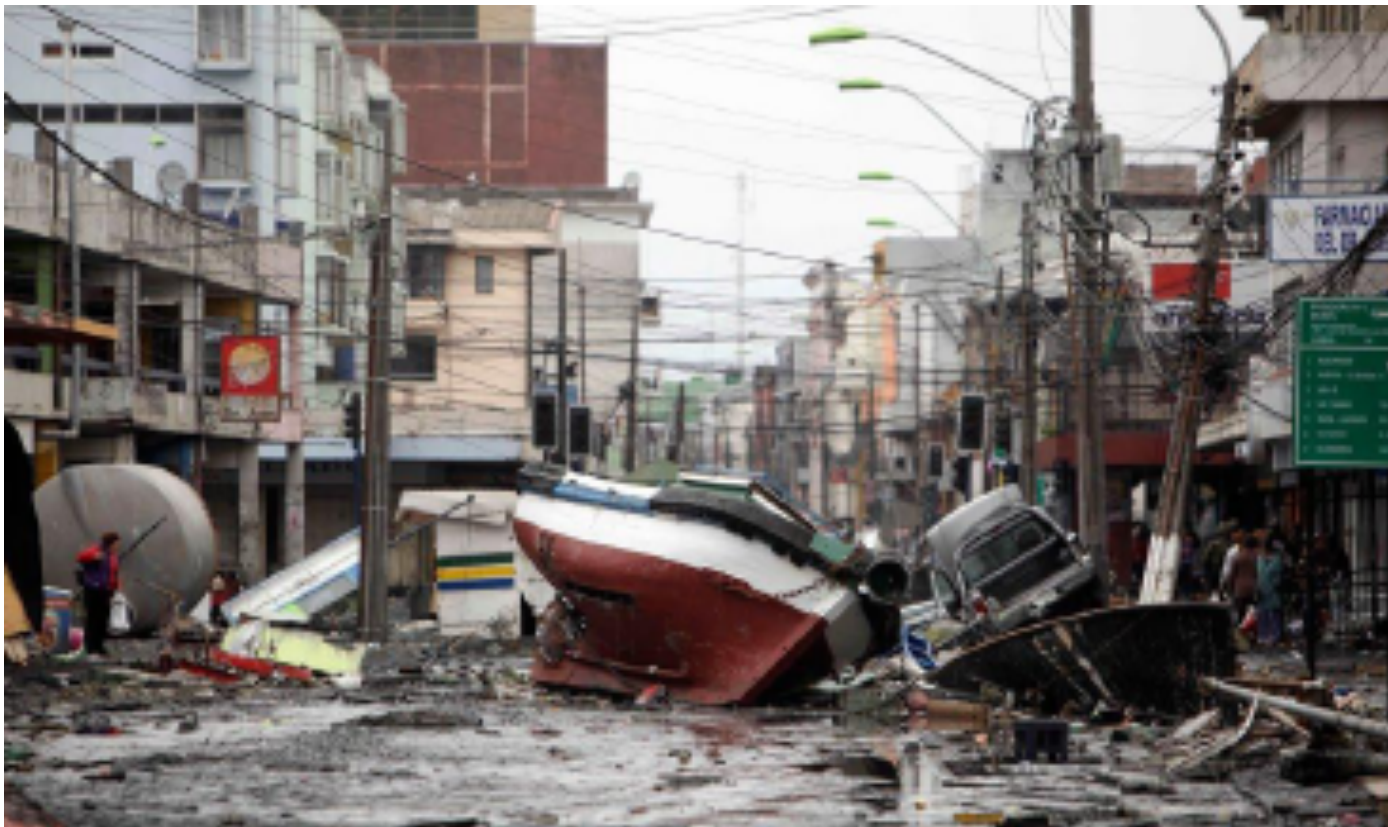
- Distribution infrastructure still standing after earthquake and tsunami

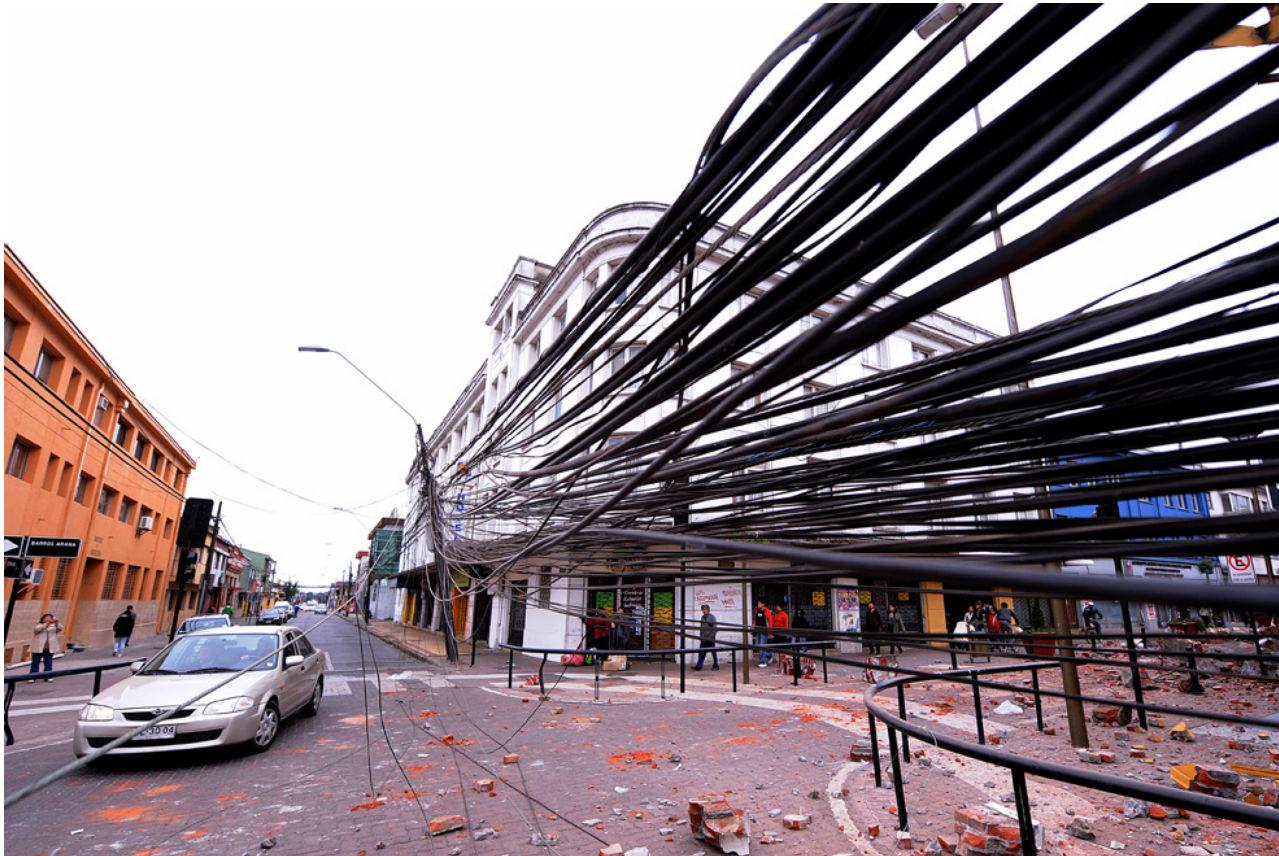
- Heavily loaded poles in main cities
