Restoring Electricity Supply After the 2010 Chilean Earthquake

Disaster Management

Hugh Rudnick, Sebastian Mocarquer, Eduardo Andrade, Esteban Vuchetich, and Pedro Miquel

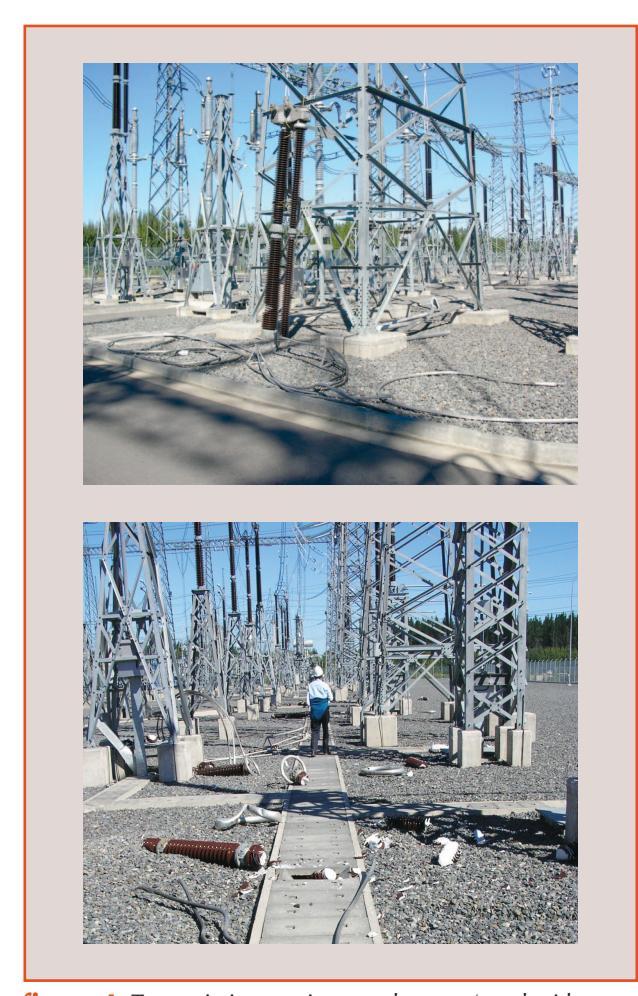
systems in Chile, SIC and SING. The earthquake was a first-class test for the seismic specification of equipment and civil infrastructure, but some equipment was damaged in the SIC (see Table 1). Damage at the substation level, shown in Figure 4, was mainly focused on:

- ✓ 500-kV bushings
- ✓ 500-kV pantograph disconnector switches
- ✓ 220-kV circuit breakers (live-tank type)
- ✓ 154-kV circuit breakers (compressed-air type).

The failures that affected equipment belonging to utilities across the country share an important common element. Standard procedures in the design of wire connections between pieces of equipment in the layout of the switchyards were not always followed. It is fundamental that the span of these connections allow the equipment to move almost freely during an earthquake. In many cases, the tension transmitted through these wire connections exceeded the design

figure 4. Transmission equipment damage (used with permission from Transelec).

requirements of the equipment. And certain solutions, like the installation of surge arresters at the top of a transformer's fire protection walls, seem to be flawed, since several of these devices failed.

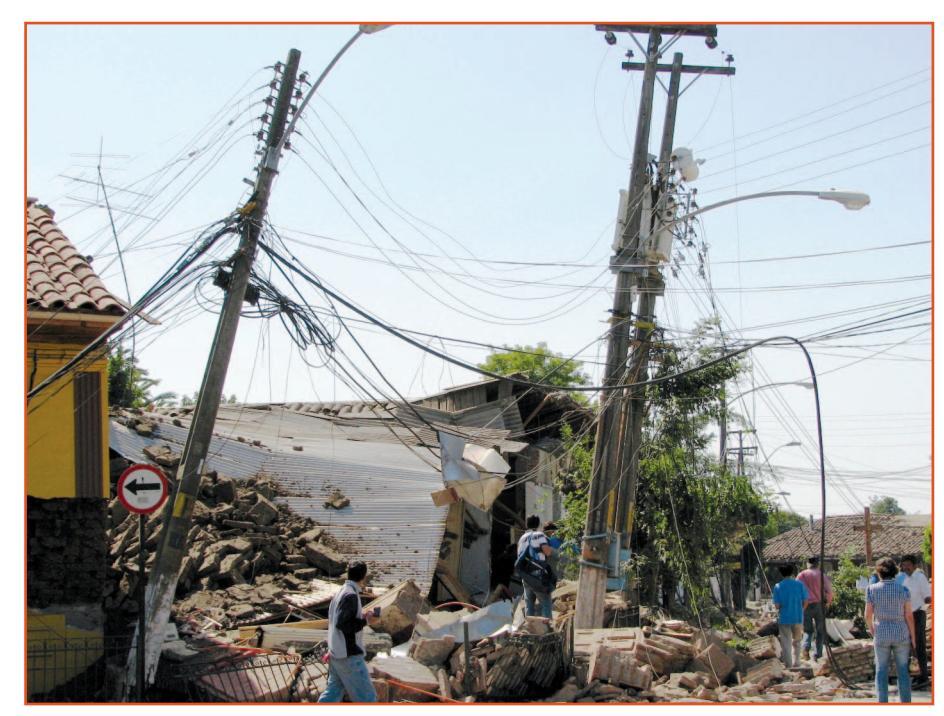
Some distribution poles and line spans were directly destroyed by the effects of the earthquake, as houses fell over street lines or were simply washed away by the tsunamis (Figures 6 and 7). In all, 40,000 houses were destroyed out of 1.5 million supplied by CGED. The materials and

figure 6. Damage from the earthquake in Talca (used with permission from CGED).

equipment used in distribution did not suffer from design or construction failures, however; damage was principally due to the collapse of nearby walls, landslides, or the tsunamis, and there was little damage elsewhere. Distribution poles in Chile are mainly compressed prestressed concrete poles set on sturdy foundations that can tolerate significant mechanical stresses. The electric wires supported by these poles do not impose any significant mechanical requirements. In urban areas, however, the poles also support communication cables (cable TV and telephone) that are heavier and impose larger requirements than the electric wires. In several cases, it was the poles supporting the additional heavy loads that were damaged. Aerial distribution transformers are often placed between two poles and a steel support; thus they also tolerate earthquakes well.

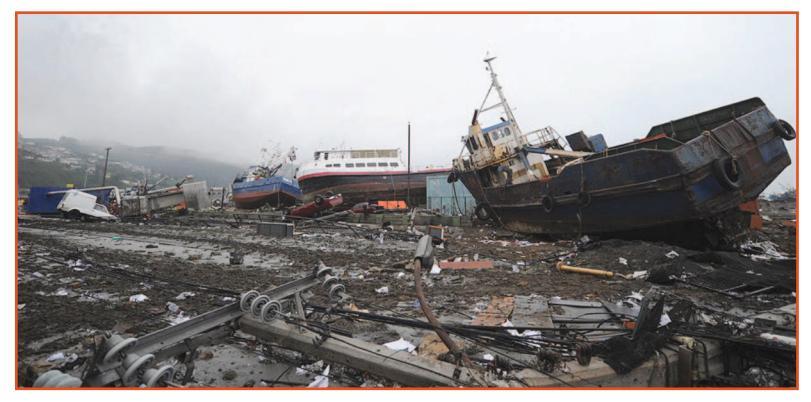
figure 7. Effects of the tsunami in Talcahuano (used with permission from CGED).
