Lessons from the 2010 Chilean earthquake and its impact on electricity supply

J.C. Araneda, *Senior Member, IEEE*, H. Rudnick, *Fellow, IEEE*, S. Mocarquer, *Member, IEEE*
and P. Miquel

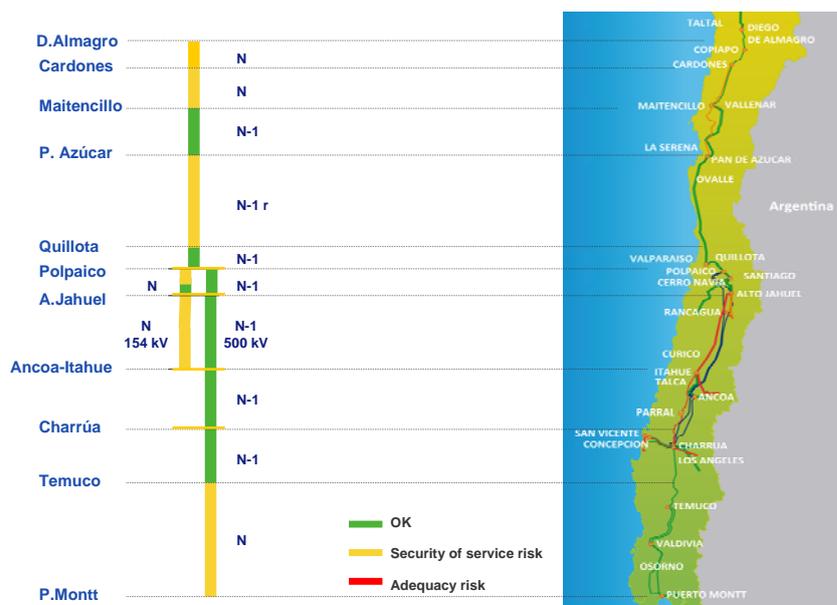
Figure 12.- Security of service level in the SIC main transmission system

The security of service level in the transmission system in Chile is measured via the use of the N-1 criteria. The N-1 criteria or single contingency criteria, commonly used in the planning and operation of power systems throughout the world, allows the system to operate normally in front of any outage on equipments or facilities, either a line circuit or a generating unit, without a cascade propagation on the rest of the system facilities. Figure 12 shows the current security level in the SIC main transmission system [11]. Several sections in the system do not have the infrastructure to operate with N-1 criteria. In fact, the 500/220 kV transformation capacity at Charrúa did not operate with N-1, and its disconnection overloaded networks and caused the collapse.
