# Lessons from the 2010 Chilean earthquake and its impact on electricity supply

J.C. Araneda, *Senior Member, IEEE*, H. Rudnick, *Fellow, IEEE*, S. Mocarquer, *Member, IEEE* and P. Miquel

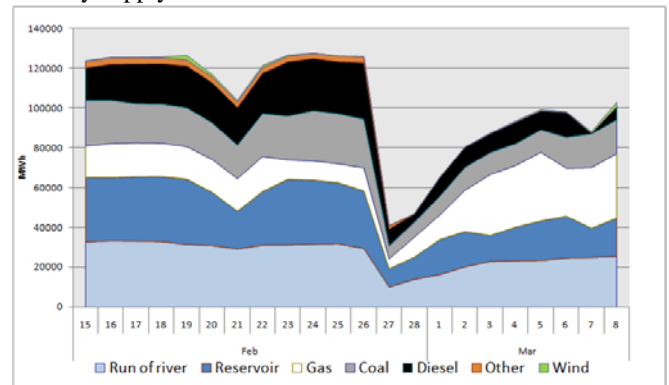
Conditions were different for electricity transmission. The Chilean main grid, given the geographical shape of the country, is a longitudinal one extending for around 2000 km, with most of the grid built to cope with N-1 security conditions, except for transformation equipment. Although the earthquake damaged some transmission equipment, the grid was still able to operate (now with an N security condition in several places) and, in fact, supply at the main grid level was recovered in a few hours after the quake. A two island scheme was used for operation, the central part of the country separated from the south, given the damage at some substations and isolated problems in transmission. Two days after the two islands were interconnected. Figure 2 illustrates the way supply evolved over time.

Figure 2.- Evolution of supply before and after earthquake (Ref.: Systep)

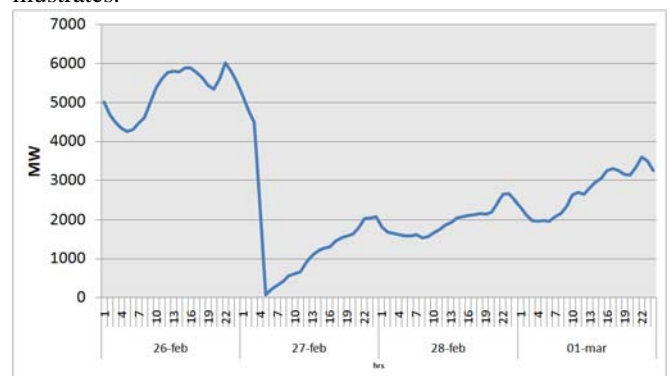
Nevertheless, the fast supply recovery at the generation-transmission level did not necessarily mean that supply to the end consumer was recovered as fast. The distribution networks were severely damaged in several parts of the country, and although repairs were made, it took several days or even weeks to complete. There were coastal regions where the distribution network was completely destroyed. Load dropped 3,000 MW and recovered slowly, as figure 3 illustrates.

Figure 3.- Evolution of hourly load after the earthquake (Ref.:Systep)

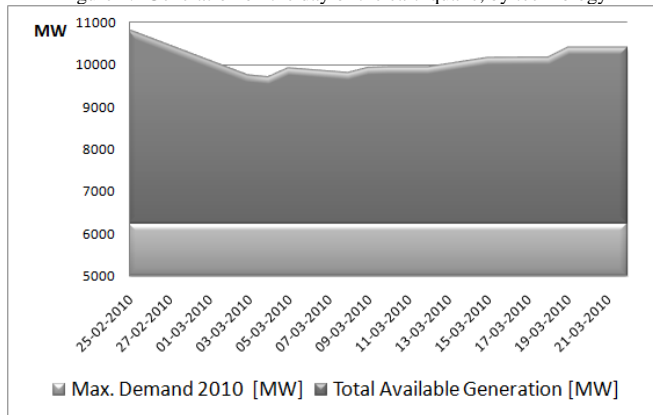
Figure 5.- Evolution of the availability of the generation facilities.

A total of 2,257 MW from 24 generation plants, most of them thermal, were damaged but were available for dispatch in the following days after the earthquake. Most of the damages suffered were minor, but required repairs, such as faults in cooling systems, loss of communication, transmission lines and transformers, etc. In the other hand, 693 MW from 16 generation plants require major repairs and some of them can be out of service up to six months due to the severity of the damages.

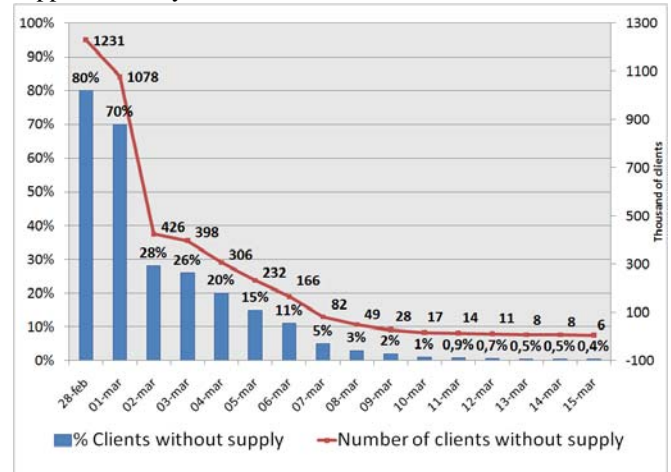
Most of the load was not supplied for weeks due to problems that arose in the distribution network. In effect, four and a half million people were initially affected by the extended blackout that took place because of the earthquake and it took days, and even weeks in some areas, to recover full supply. Chilectra distributes energy in Santiago, the capital, while three distribution companies service the most affected areas, CGE, Emelectric and Emelat. Figure 7 illustrates the impact in the most affected area, and how electricity supply was recovered over time [12]. 80% of clients were without supply the day after the earthquake and this reduced to 0.4% two weeks after. This last percentage related mainly to Concepcion and Talcahuano, next to the earthquake epicenter, the latter being also hit by the consequent tsunamis.

Figure 7.- Evolution of clients without electricity supply (Source: CGE)

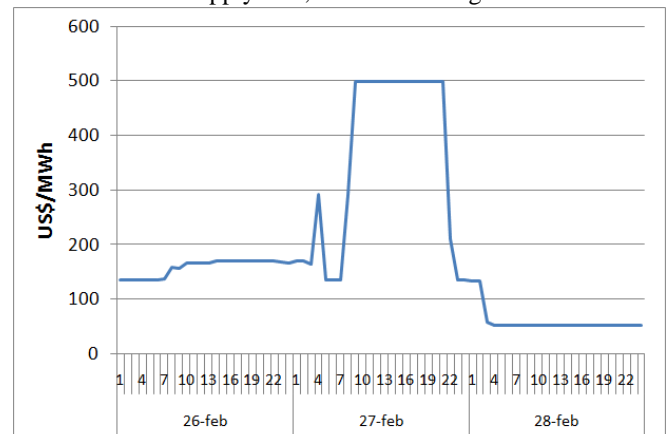
Operation and market wise, when the two islands were isolated, spot prices at the main busbar at the earthquake area reached the non-supply cost, as shown on figure 11.

Figure 11.- Hourly spot prices at Charrua (Source: CDEC-SIC)

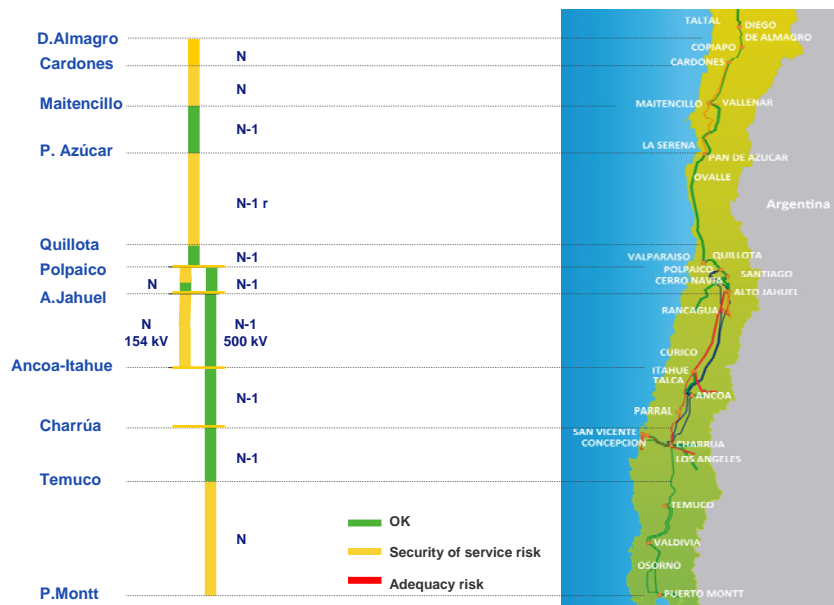
The security of service level in the transmission system in Chile is measured via the use of the N-1 criteria. The N-1 criteria or single contingency criteria, commonly used in the planning and operation of power systems throughout the world, allows the system to operate normally in front of any outage on equipments or facilities, either a line circuit or a generating unit, without a cascade propagation on the rest of the system facilities. Figure 12 shows the current security level in the SIC main transmission system [11]. Several sections in the system do not have the infrastructure to operate with N-1 criteria. In fact, the 500/220 kV transformation capacity at Charrúa did not operate with N-1, and its disconnection overloaded networks and caused the collapse.

Figure 12.- Security of service level in the SIC main transmission system
