Restoring Electricity Supply After the 2010 Chilean Earthquake

Disaster Management

Hugh Rudnick, Sebastian Mocarquer, Eduardo Andrade, Esteban Vuchetich, and Pedro Miquel

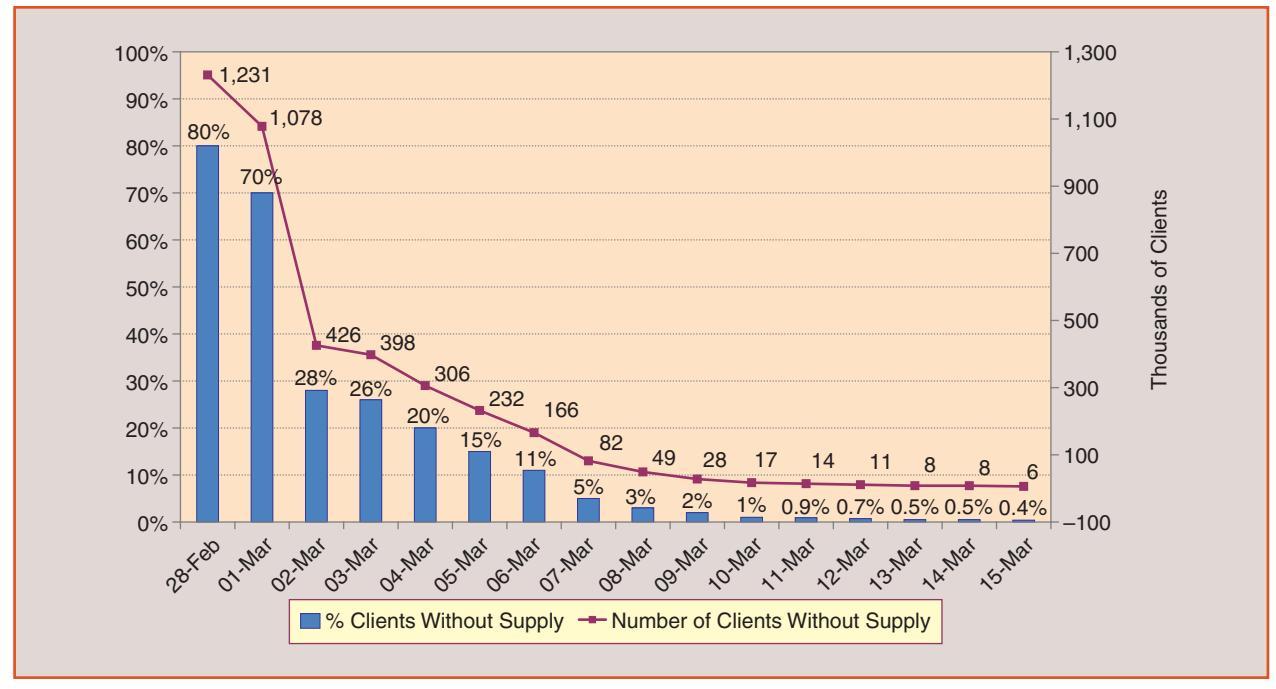
figure 5. Impact on distribution and restoration of electricity supply (source: CGED).

Total normal load supply was achieved only after several days, due to problems that arose in the distribution network. In effect, 4.5 million people were initially affected by an extended blackout caused by
