Lessons from the 2010 Chilean earthquake and its impact on electricity supply

Juan Carlos Araneda, *IEEE Senior* (jcaraneda@transelec.cl)

Hugh Rudnick, *IEEE Fellow* (hrudnick@ing.puc.cl)

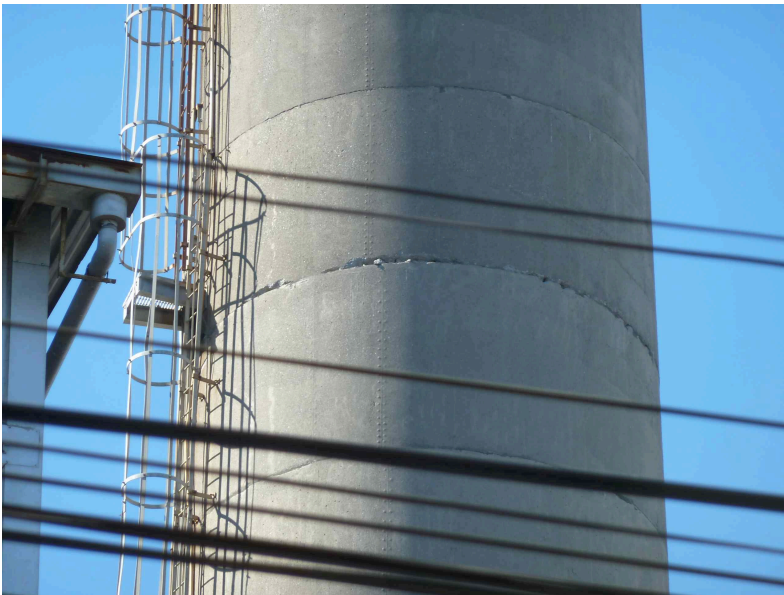
Damage to generation plants

- Mainly thermal generation plants sustained damages
- Also important plants under construction suffered damages, delaying their commissioning
- Most common problems:
 - Cooling systems, transformers, communications, lines, etc

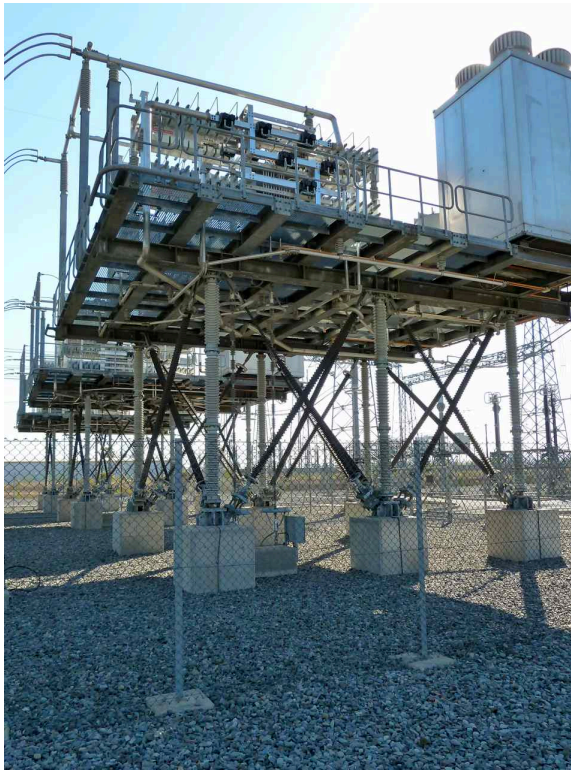
Transmission damages

- But most remained available

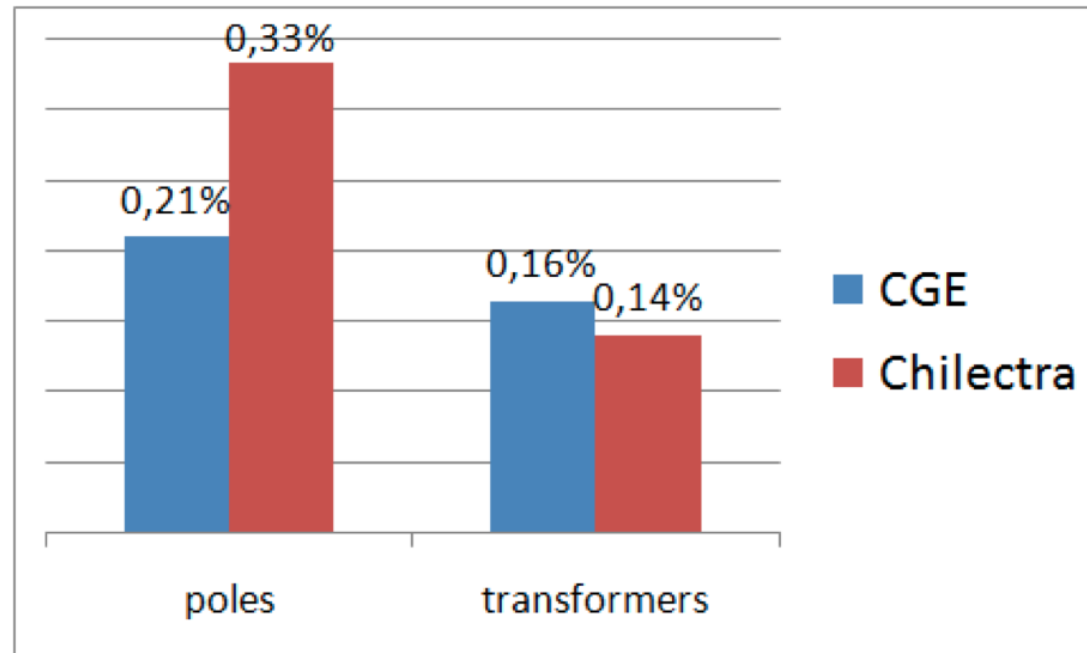
Equipment damage at distribution level

- Small proportion of distribution equipment was damaged

760,000 poles in CGE

300,000 poles in Chilectra
